Manhole Inspection Summary

Manhole # S13MM_049MH

Insp Date: **8/31/07 11:58 AM**

Location Address: **2901 POPLAR TERR**

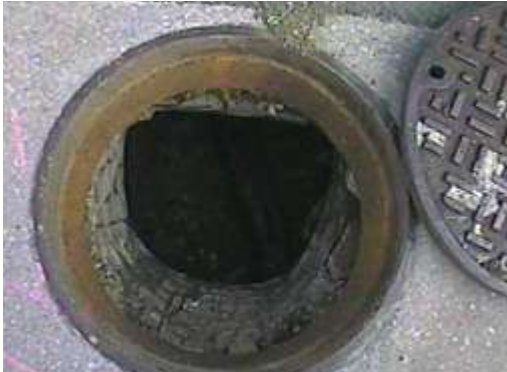
Frame Offset: **8** (in.) Condition: ☒ Sound ☐ Cracked ☐ Leaks

FRAME OFFSET

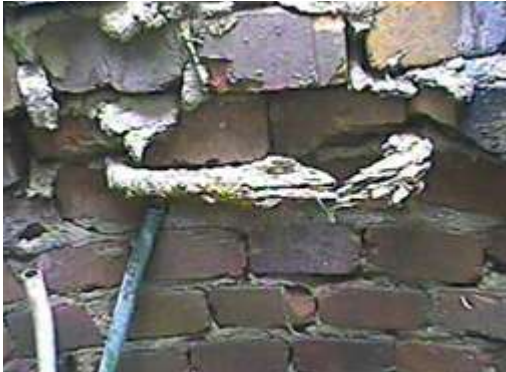
Defect 2

Steps Count: **2** Missing: **0** ☒ **Corroded**

CORRODED RUNG

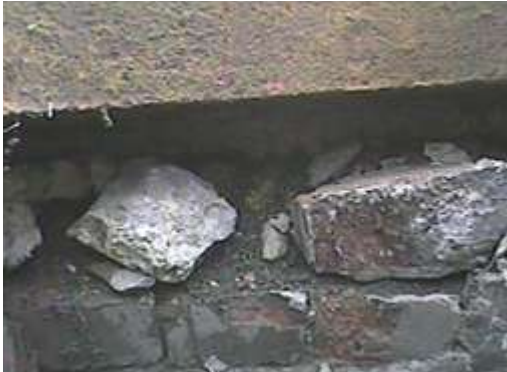
Defect 1

Condition: ☐ Sound ☐ Cracked ☐ Root Intrusion ☒ **Loose Brick** ☒ **Deteriorated**

LOOSE BRICK ADJ.

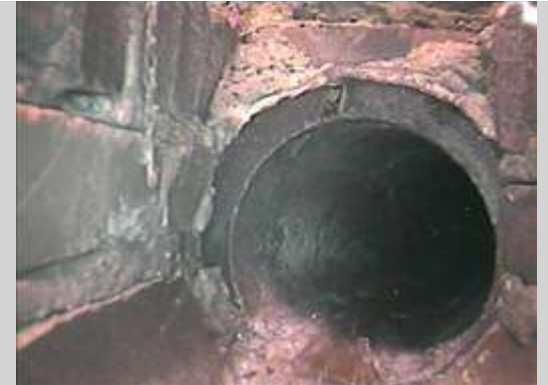
12 O'Clock Outflow

8 in. Circular Gravity Sewer
Pipe Out @ 12 O'Clock

Pipe Height: (in.) Direct
Pipe Material: **Clay** ☐ Pipe Lined
Invert Depth: **6.54** (ft.) Flow Characteristics: **Fast**
Deposits: ☒ None ☐ Mud ☐ Sludge ☐ Debris ☐ Grease
Silt Depth: (in.) Deposits Extent:
Infiltration: **None** Pipe Seal Cond: **Sound**

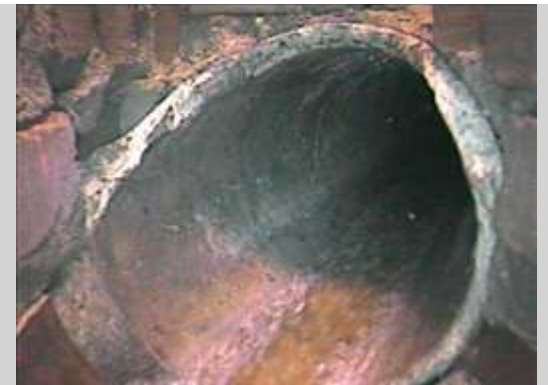
6 O'Clock Inflow

8 in. Circular Gravity Sewer
Pipe In @ 6 O'Clock

Pipe Height: (in.) Direct
Pipe Material: **Clay** ☐ Pipe Lined
Invert Depth: **6.38** (ft.) Flow Characteristics: **Fast**
Deposits: ☒ None ☐ Mud ☐ Sludge ☐ Debris ☐ Grease
Silt Depth: (in.) Deposits Extent:
Infiltration: **None** Pipe Seal Cond: **Cracked**
